Navajo Abandoned Uranium Mine

Site Screen Report

Block K AUM Site

August 2010

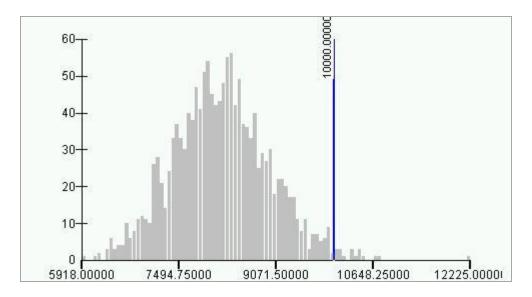
The following chart and statistics were generated by ESRI ArcGIS 9.3.1, and show the general distribution of the site gamma radiation measurements. The horizontal X axis represents the gamma radiation reading levels in cpm (lowest levels to the left). The vertical Y axis represents the frequency of each gamma radiation level.

Maximum:
 12225.00000

Mean:
 8180.83023

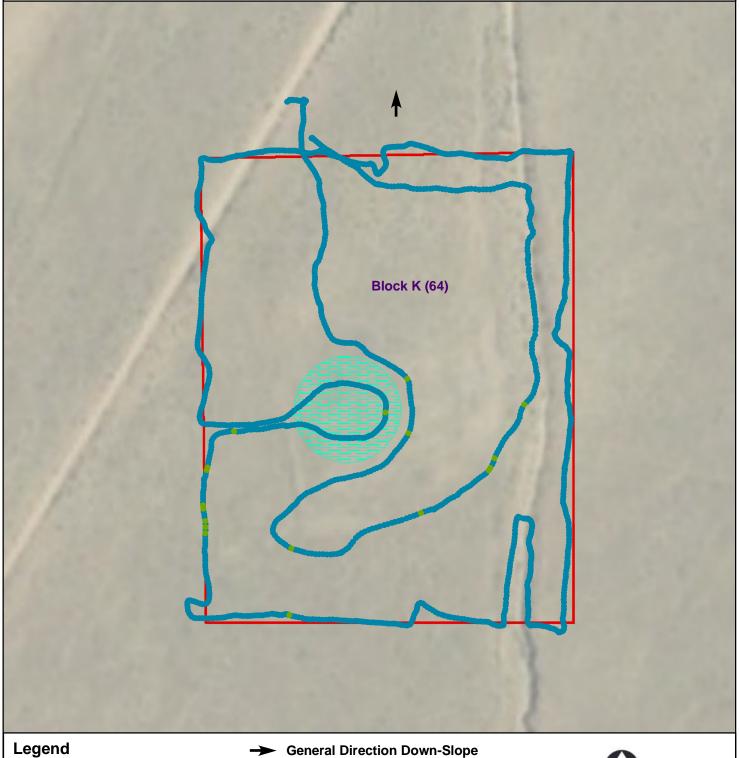
Figure 2 - Gamma Radiation Measurements Block K (64) Teec Nos Pos Chapter, Navajo Nation

A total of 1,449 gamma radiation measurements were collected from the mine site, ranging from 5,918 cpm to 12,225 cpm. The measurements are represented in Figures 1 and 2.

Gamma survey conducted 06/2010 Measured as counts per minute (cpm)

Average background 7,684 cpm
